**Flood Control Project Maintenance
Levee Inspections**
LMA District Cover Sheet
Spring 2011 Levee Inspection Results

Reclamation District No. 0404 Boggs

Levee Inspection Report By Mile - Spring 2011

Waterway						Bank	Unit Miles	Inspection Start/End	Inspector	
Unit No. 01 San Joaquin River						Right	2.36	04/14/2011 04/14/2011	Richard Willoughby	
LMR No.	Levee Mile		Category	Item	Location	Rating	Action/Comment	GPS Latitude/Longitude		Issue No.
	Start	End						Start	End	Photo
1	0.00	2.36	Earthen Levee	Vegetation	LS	M	Control annual grass and weeds on the levee slopes and easements.	37.942105 ° -121.345183 °	° °	13
2	0.00	2.36	Earthen Levee	Vegetation	WS	M	Control annual grass and weeds on the levee slopes and easements.	37.942103 ° -121.345182 °	° °	14 Y
3	0.03	0.48	Earthen Levee	Vegetation	LS	W	Remove the wild growth other than native grasses from the levee slopes.	37.941695 ° -121.344917 °	37.939652 ° -121.338373 °	5 Y
4	0.03	0.20	Earthen Levee	Vegetation	WS	W	Remove the wild growth other than native grasses from the levee slopes.	37.941697 ° -121.344917 °	37.939853 ° -121.343210 °	8 Y
5	0.21	0.25	Supplemental	DWR Erosion Survey	WS	U	Inspector Comments: 9/07/2010: No significa

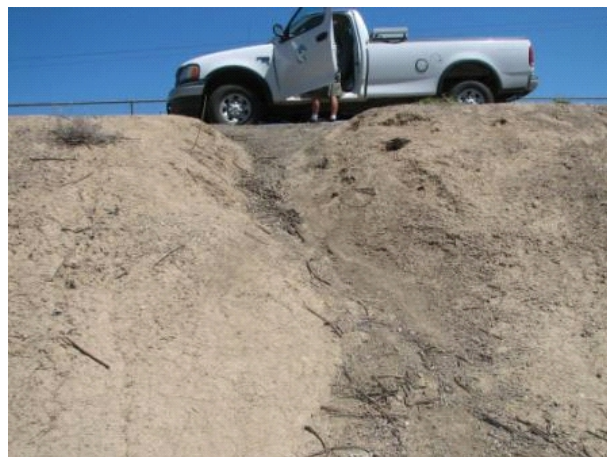
richard_s_20110215_123.jpg

Photo taken in 2007.

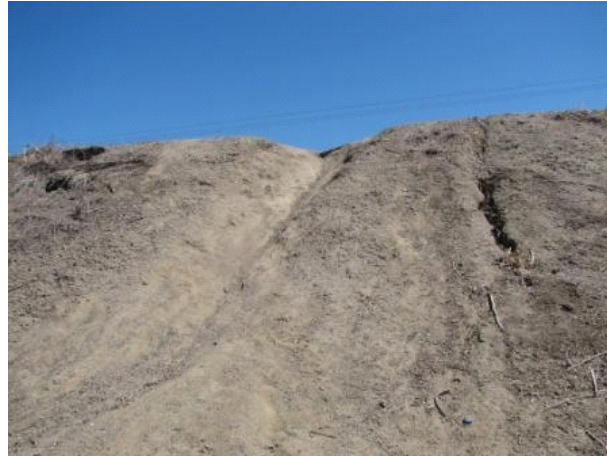
richard_s_20110215_124.jpg

Levee Mile Report Line	10
Start Levee Mile	1.32
End Levee Mile	1.58
Location	Water Side
Category	Supplemental
Item	DWR Erosion Survey

Photo taken in 2007.

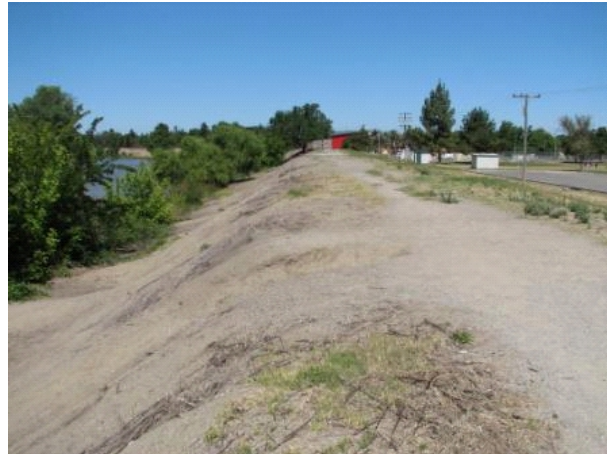
richard_s_20110215_125.jpg

Levee Mile Report Line	10
Start Levee Mile	1.32
End Levee Mile	1.58
Location	Water Side
Category	Supplemental
Item	DWR Erosion Survey

Photo taken in 2007.

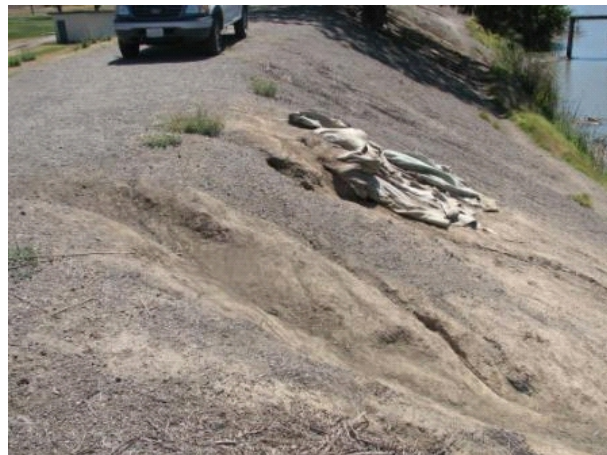
richard_s_20110215_126.jpg

Levee Mile Report Line	10
Start Levee Mile	1.32
End Levee Mile	1.58
Location	Water Side
Category	Supplemental
Item	DWR Erosion Survey

Photo taken in 2007.
